HAMBURG DAM AND RESERVOIR

PHASE I INSPECTION REPORT NATIONAL DAM INSPECTION PROGRAM

HAMBURG RESERVOIR
BERKS COUNTY, PENNSYLVANIA
NATIONAL I.D. NO. PA 00718

Name of Dam: Hamburg Reservoir
County Located: Berks County
State Located: Pennsylvania
Stream: Furnace Creek
Coordinates: Latitude 40° 35.1' Longitude 75° 56.5'
Date of INSpection: 18 July 1978

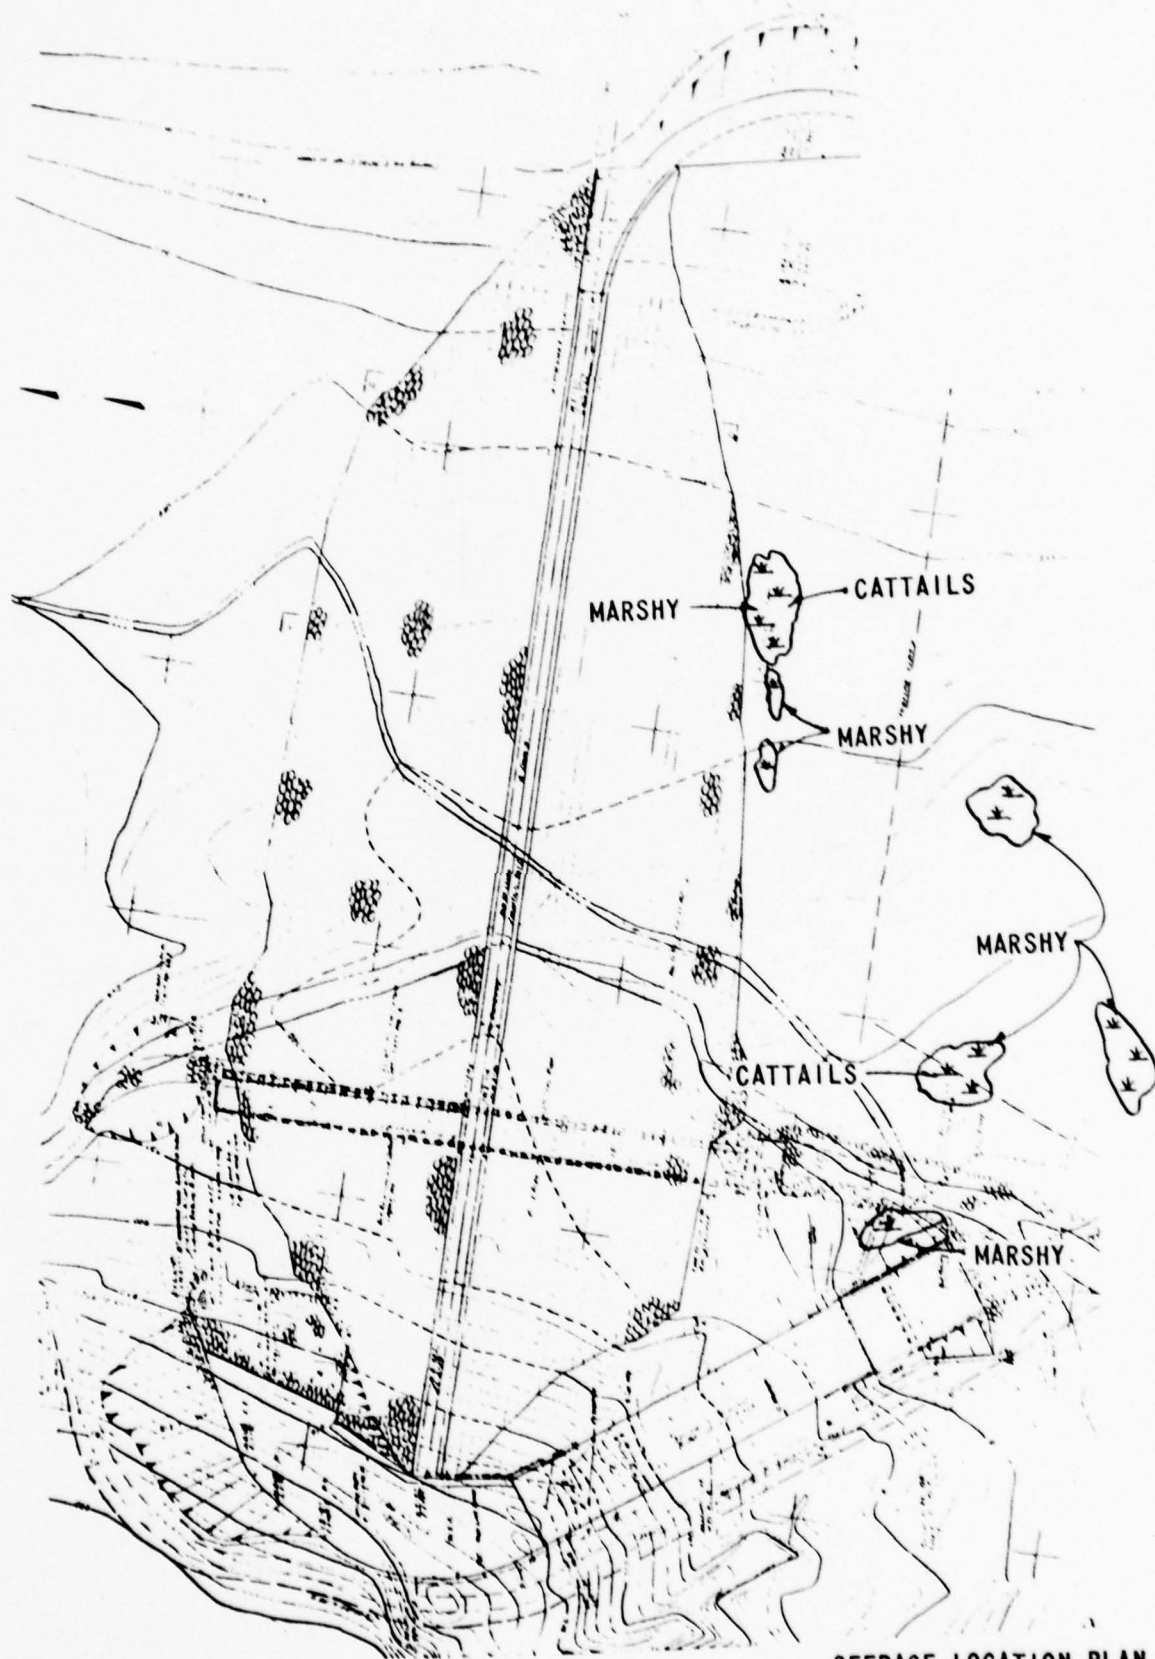
SEEPAGE LOCATION PLAN
HAMBURG RESERVOIR DAM

The seepage noted downstream, and delineated on Sheet 5a, is expected considering the sand and gravel foundation materials. There is no evidence to indicate an imminent potential for piping or slope instability because of this seepage. However, this seepage, as well as the seepage from the 30-inch pipe, should be monitored and the rates of flow measured and recorded to determine if there are any changes in rates or changes in turbidity. If the quantity should significantly increase or the flow become turbid, the condition should be studied in detail and necessary remedial measures taken. The exposed portions of the outlet works and pond drain systems were inspected and observed to be in good condition. The spillway was also found to be in good condition with no signs of significant deterioration.

Seepage was noted downstream from the toe and in several areas adjacent to the embankment toe, as shown on Sheet 5a of Appendix B. This seepage is expected, but is currently not considered to be an indication of potential piping or imminent failure of the structure. This seepage, as well as seepage from the 30-inch pipe, should be carefully monitored because of the design of this structure, as described in Section I of this report. Since a comparison of seepage rates over the years has not been made, a firm assessment of the seepage could not be performed. Due to the extent of the seepage, an assessment of the seepage quantity could not be estimated.

<u>VISUAL EXAMINATION OF</u>	<u>OBSERVATIONS</u>	<u>REMARKS OR RECOMMENDATIONS</u>
DRAINS	Yes. One spring was piped from the reservoir area during construction into the intake tower discharge conduit. Details were not available since this was done quickly during the construction phase. Flow from the piped spring was observed discharging through the exit of the outlet conduit.	
JUNCTION OF EMBANKMENT AND ABUTMENT, SPILLWAY AND DAM	No discontinuities observed.	
ANY NOTICEABLE SEEPAGE	Yes. See sheet 5a. One seepage zone delineated by a 10 foot circle of cattails was noted which drained via a channel parallel to the outlet channel eventually discharging into the natural channel approximately 120 feet downstream of the impact basin. Several other marshy areas were noted as shown on sheet 5a.	
STAFF GAGE AND RECORDER	None

a. Facilities. It is recommended that the seepage areas downstream of the dam be regraded and drained into the downstream creek. All water, including the seepage from the 30-inch pond drain pipe, should be monitored for changes in rates of flow or changes in turbidity. Any rates of change in seepage or turbidity should be assessed by a registered professional engineer.

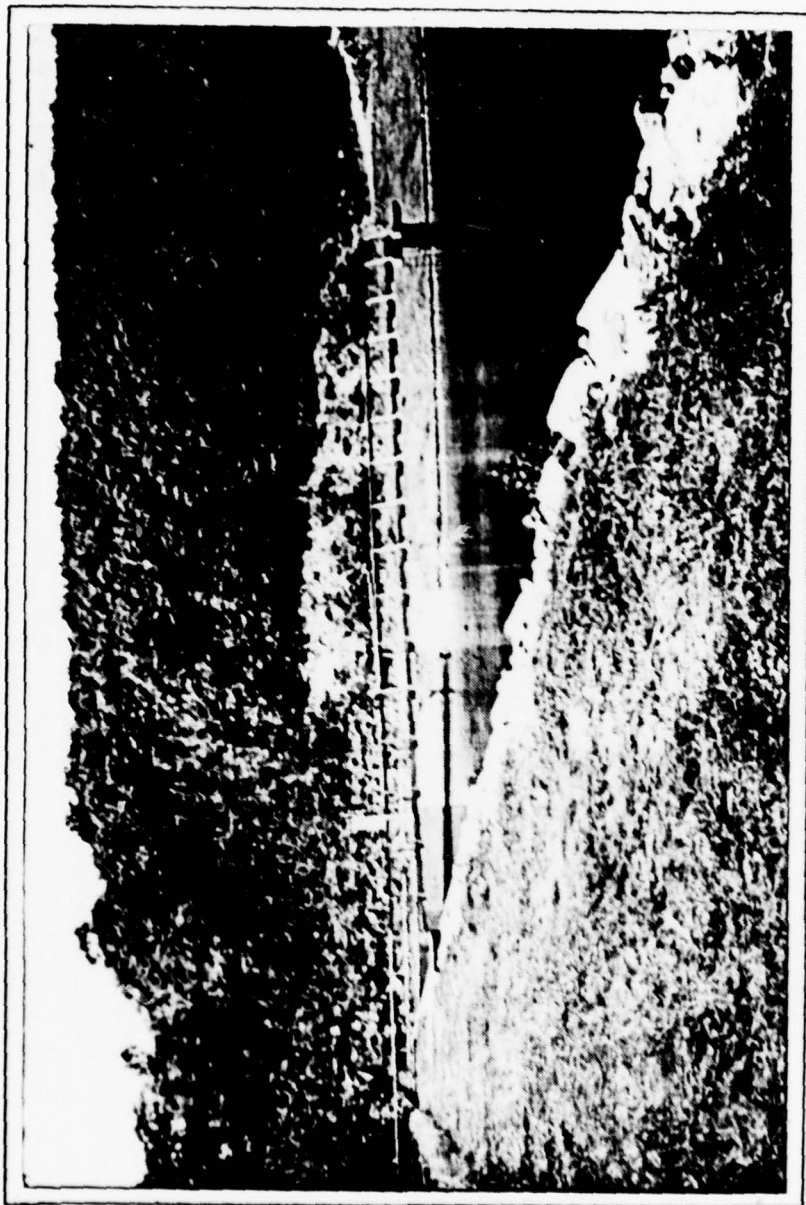
PHOTOGRAPH NO. 1

1. Intake Tower. Since the water supply intakes, discharge conduit, and most of the intake riser are beneath the water level or buried in the embankment, only the top of the tower could be inspected. This also included the exercising of the three sluice gate valves. An inspection of the access bridge between the tower and the embankment was also performed and found to be in good condition and well maintained. The Armco valves were all partially exercised and all of them worked. They are clean, well maintained and lubricated.

VIEW OF BRIDGE AND INTAKE TOWER.

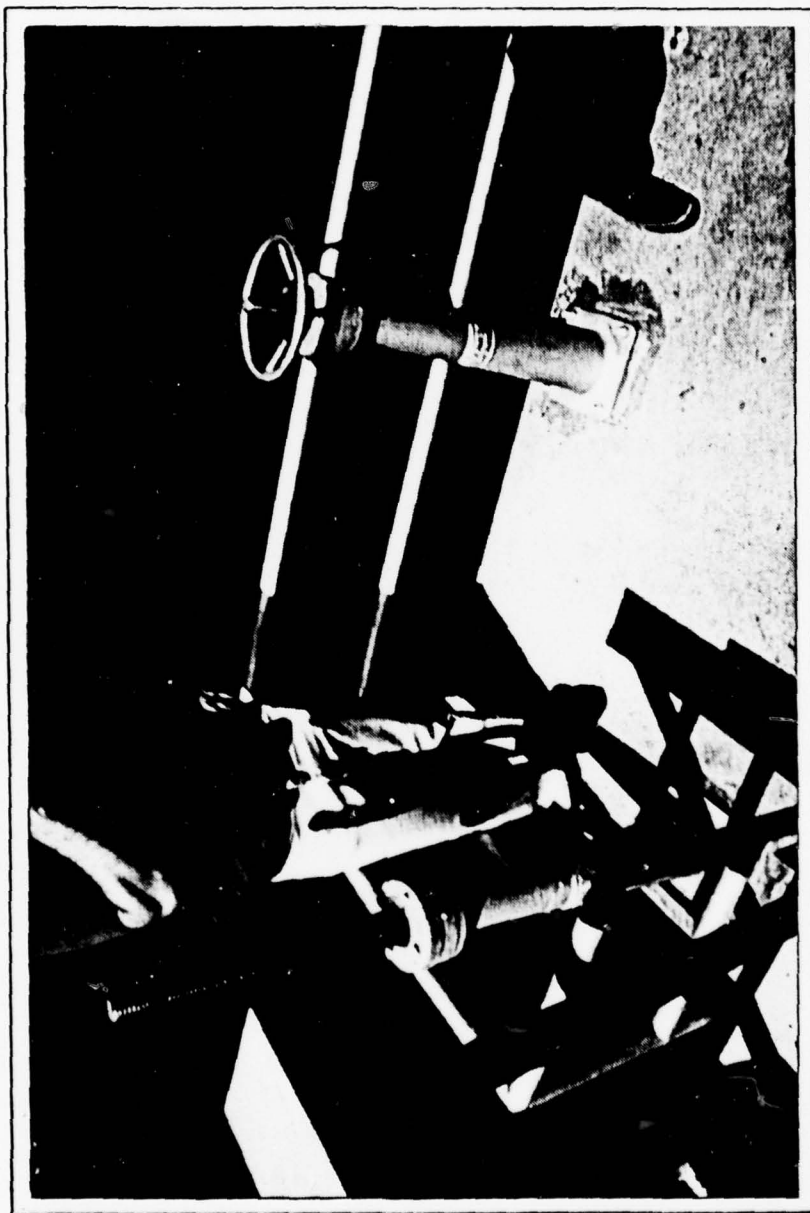
INTAKE TOWER AND INTAKE VALVES.

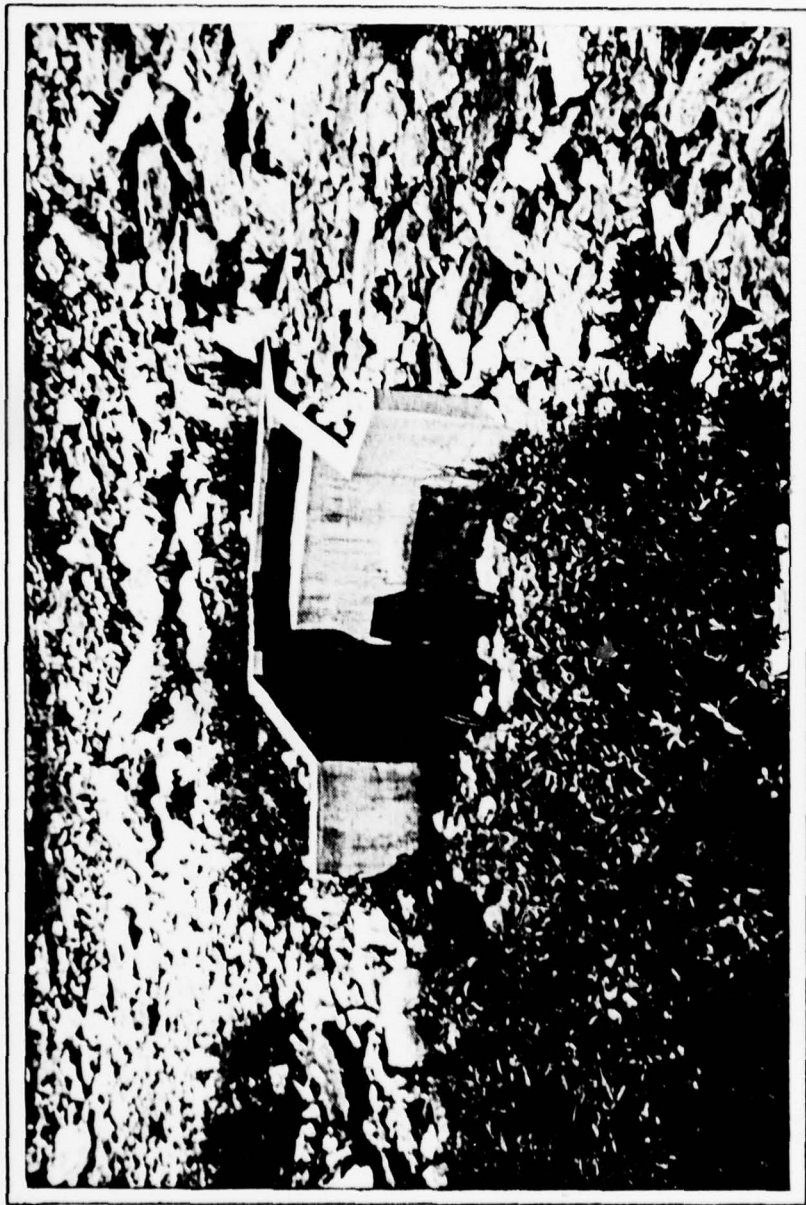
PHOTOGRAPH NO. 3

The impact basin was inspected and observed to be in good condition. There were no signs of cracks, spalling, or deterioration of the concrete. See Photograph No. 3. During the inspection, it was noted that water was flowing from the 30-inch conduit. The caretaker reported that during construction a spring was located on the left side of the reservoir and a pipe was connected from the spring to the discharge conduit. The caretaker also indicated that most of the water coming from the conduit was coming from this spring. To his knowledge, there are no as-built drawings prepared describing where this pipe was placed.

OUTLET PIPE AND IMPACT BASIN.

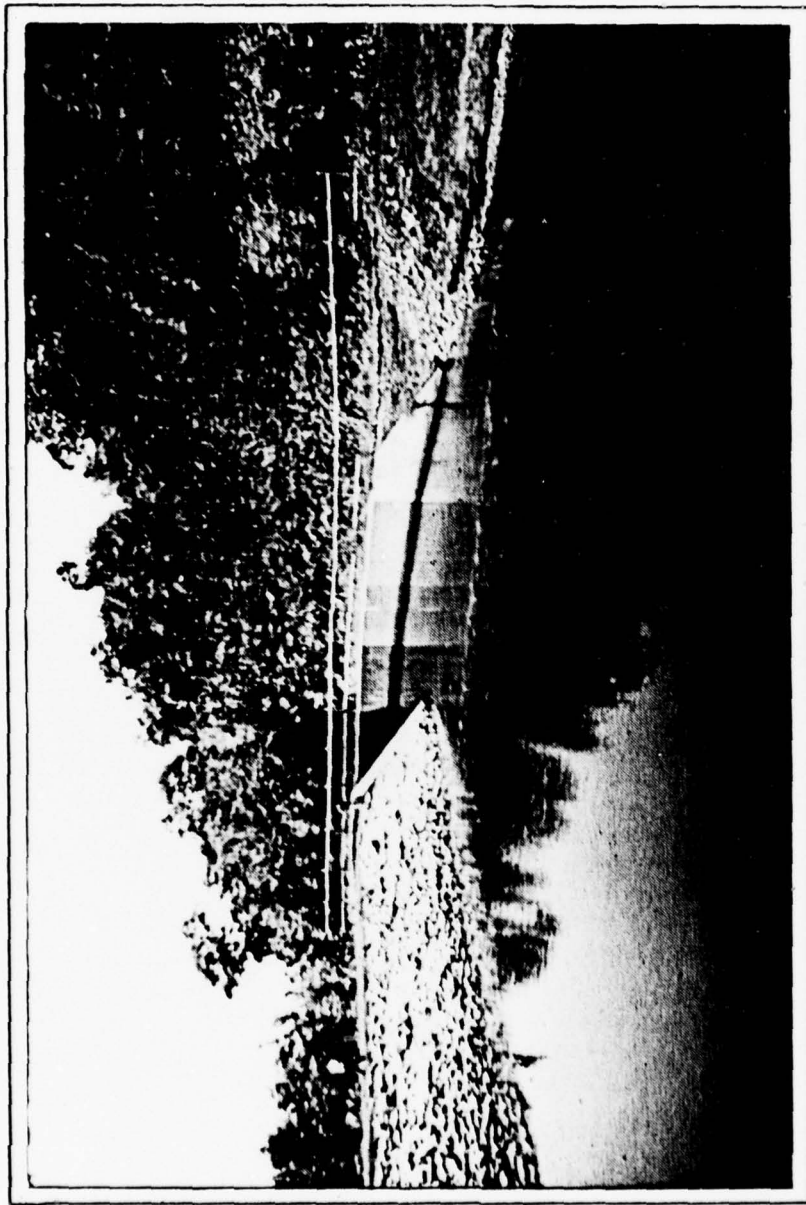
PHOTOGRAPH NO. 4

INLET CHANNEL TO SPILLWAY. NOTE
RIPRAP SLOPE.

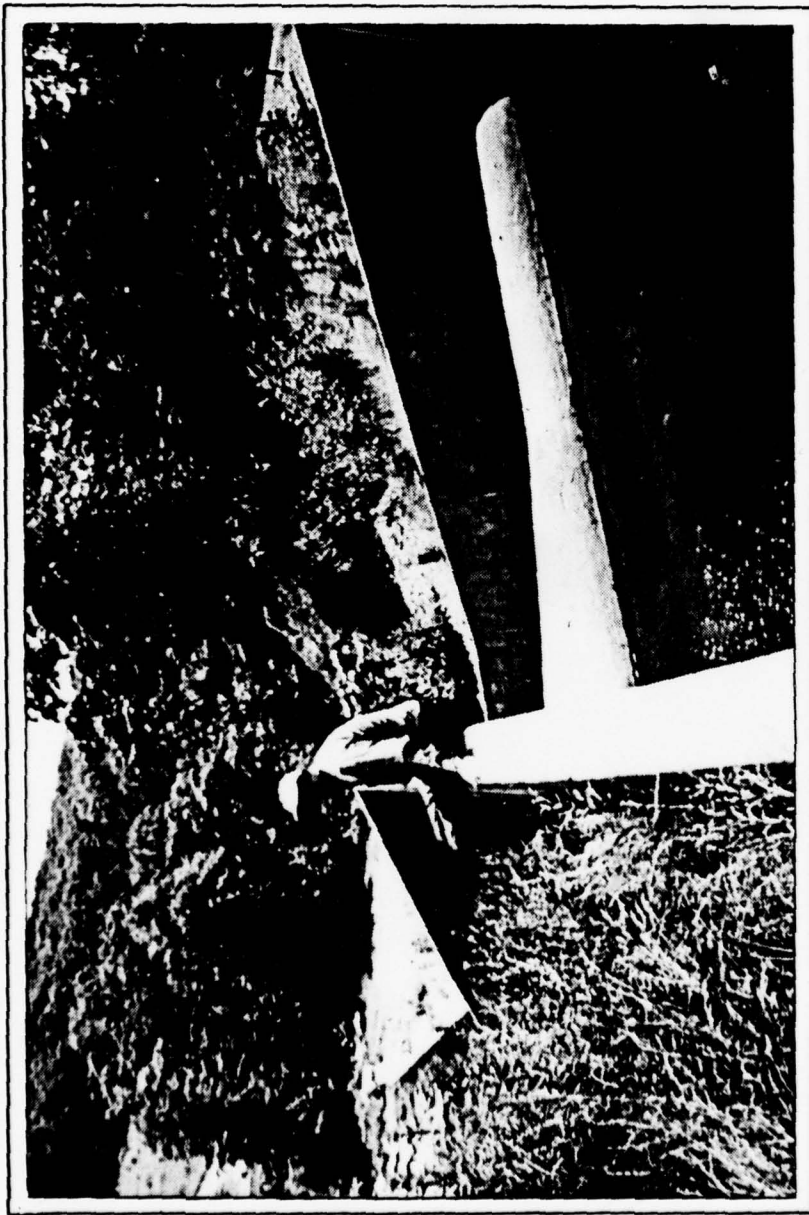
PHOTOGRAPH NO. 5

2. Spillway. The spillway was inspected and found to be in good condition. See Photographs 5 and 6. There were no cracks in the weir section or in the spillway chute. The weep holes along the spillway were dry and clear. The stilling pool was in good condition and with no signs of spalling, concrete deterioration, or other cracking. There were several hairline cracks throughout the spillway, but these were assessed to be temperature cracks, and not associated with structural distress.

SPILLWAY CREST.

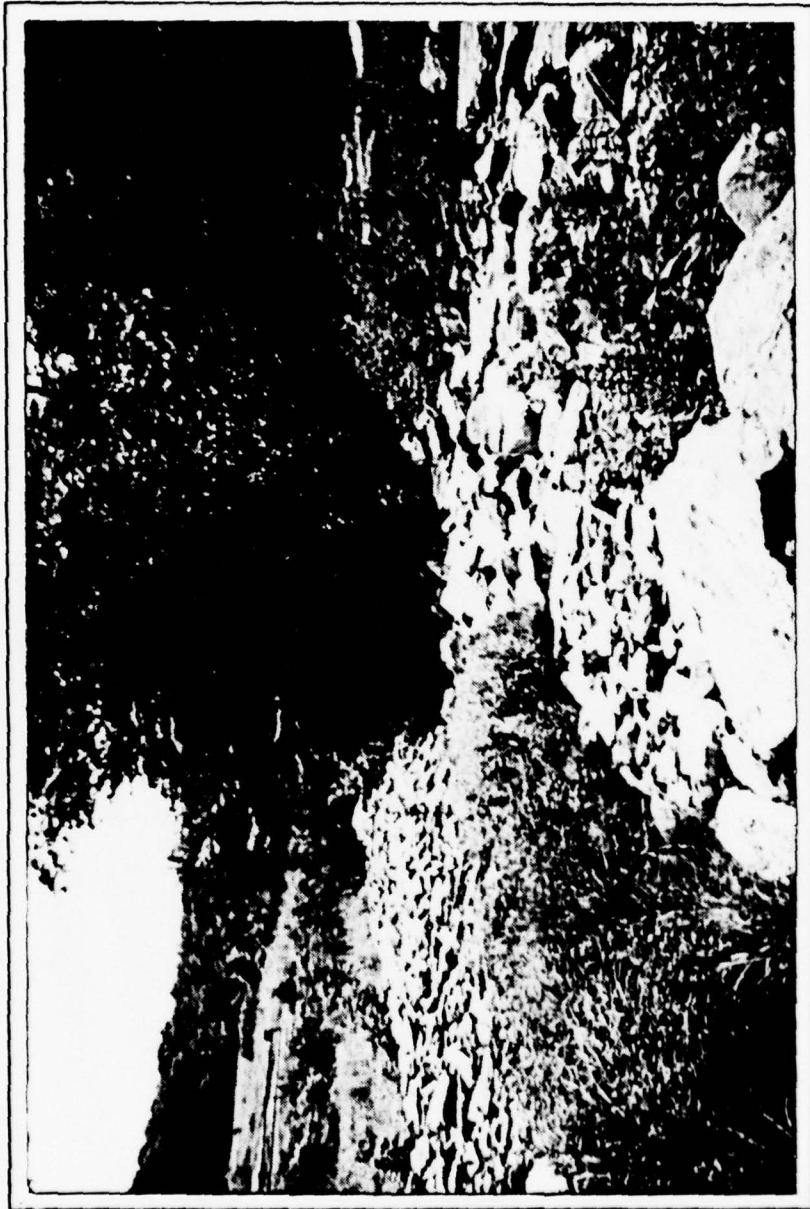
DOWNSTREAM CHANNEL WHERE OUTLET PIPE
AND SPILLWAY CHANNELS MERGE.

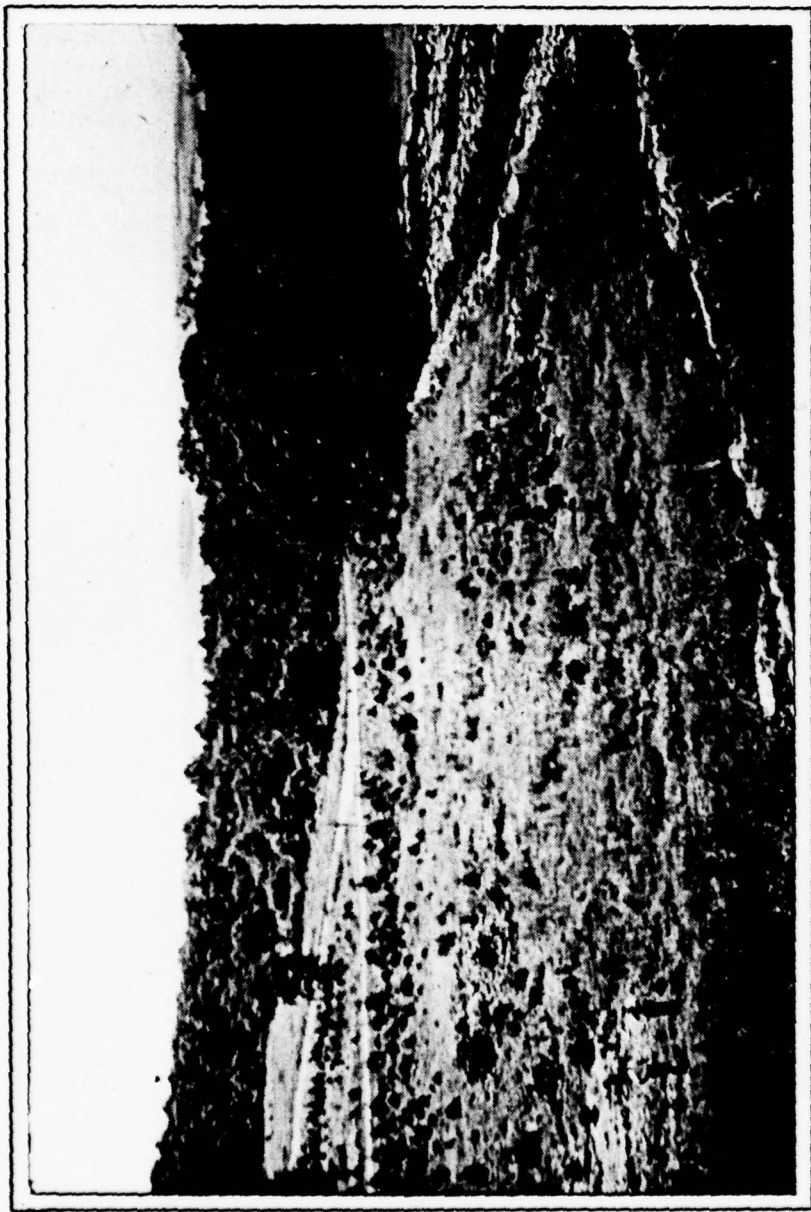
PHOTOGRAPH NO. 9

As delineated on Sheet 5a, Appendix B, some seepage was noted at several locations downstream of the dam. Considering the type of vegetation (cattails noted in the area), it is concluded that this seepage is steady and has existed for at least several years. Considering the foundation problems mentioned in the preliminary report prepared by Glace and Glace, Inc., it is expected that seepage of this nature would have occurred. However, it also appears that this seepage has been in a steady condition over many years, and that no changes are occurring. This judgment should be confirmed by seepage monitoring to determine if changes in rates of flow or changes in turbidity are occurring.

OVERVIEW OF DOWNSTREAM AREA BELOW
DAM. LUSH GREEN AREAS WITH CATTAILS
DENOTE SEEPAGE AREAS.

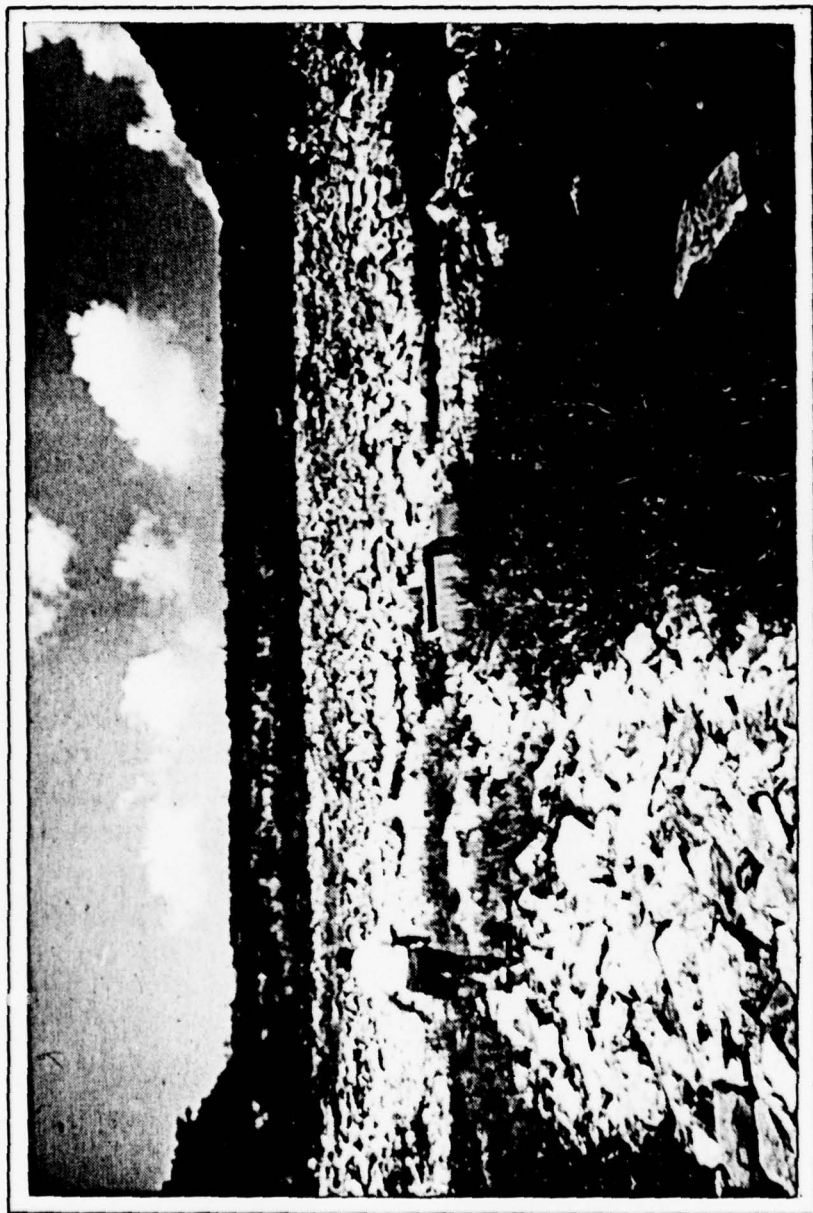
PHOTOGRAPH NO. 10

VIEW DOWNSTREAM LOOKING UPSTREAM
TOWARDS DAM.

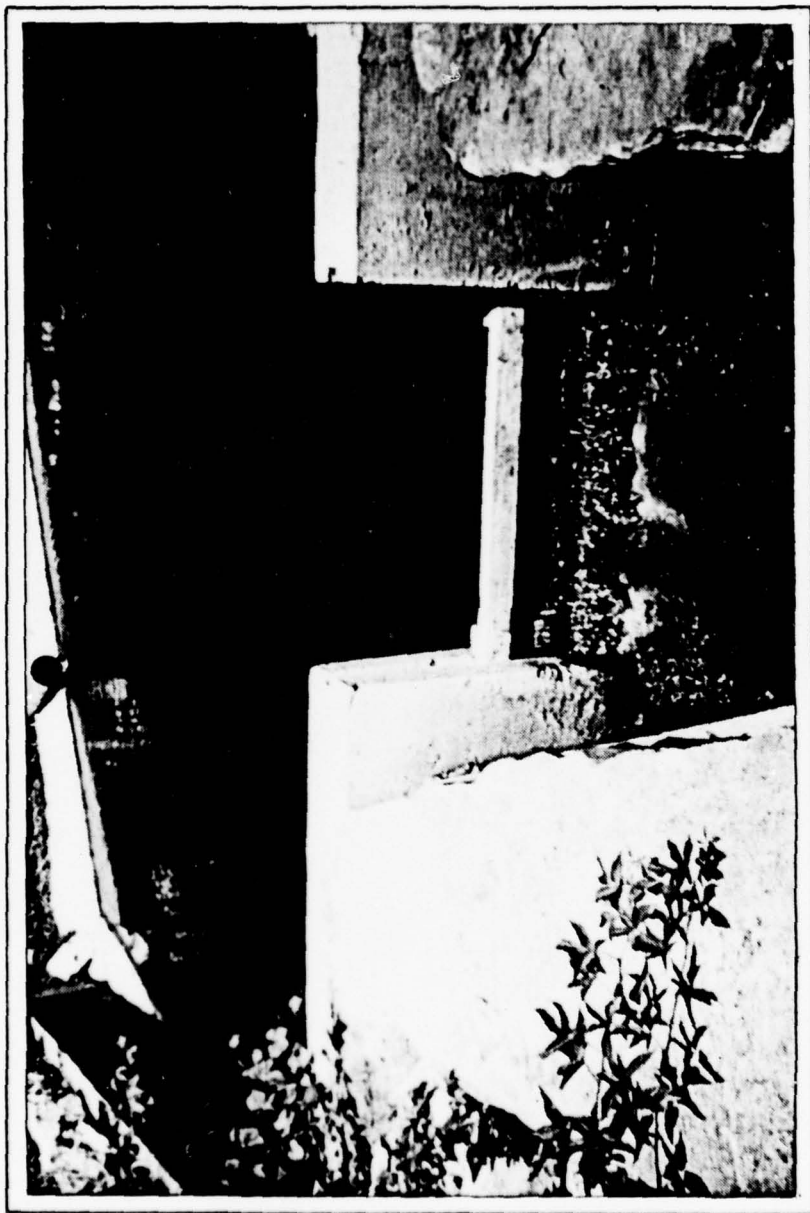
PHOTOGRAPH NO. 11

affect the flood storage capacity of the reservoir. The slopes are well vegetated and the edge of the reservoir is grass lined. See Photograph No. 8. A siltation pool was noted just upstream of the headwaters of the reservoir (Photograph No. 11).

SEDIMENT POND AND WEIR AT UPPER
END OF RESERVOIR USED TO REDUCE
RESERVOIR TURBIDITY.
